Geotechnical Report for a subdivision at Cowan Bay Road, Pohuehue

Prepared for Cowan Bay Farm Limited

Project 46953 - GEO/1 - 28/06/2017

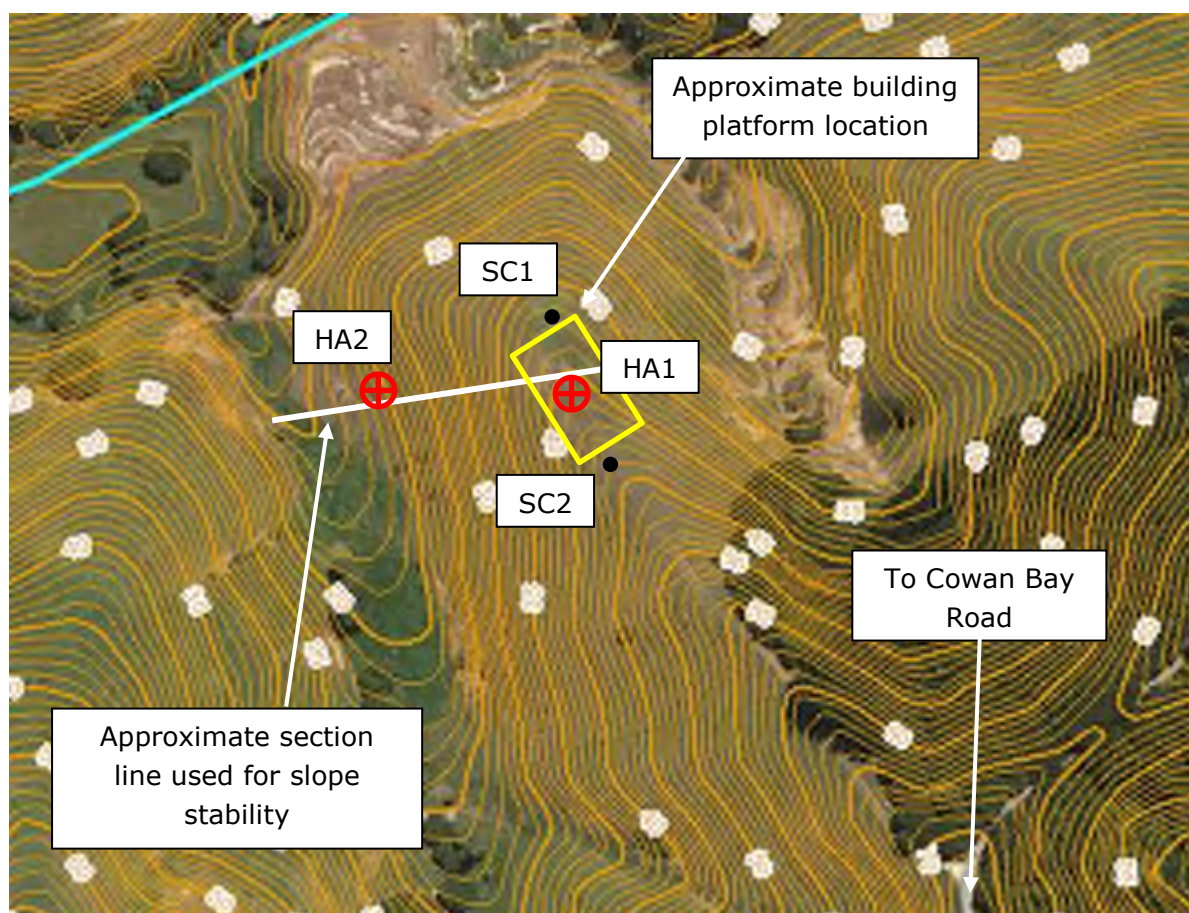
Figure 8: Approximate exploratory hole locations undertaken on Lot 5 (courtesy of Auckland Council GIS Viewer)

Exploratory holes HA's 1 – 2 and SC's 1 - 2 were undertaken on Lot 5. The approximate location of the exploratory holes is shown on Figure 8 below.

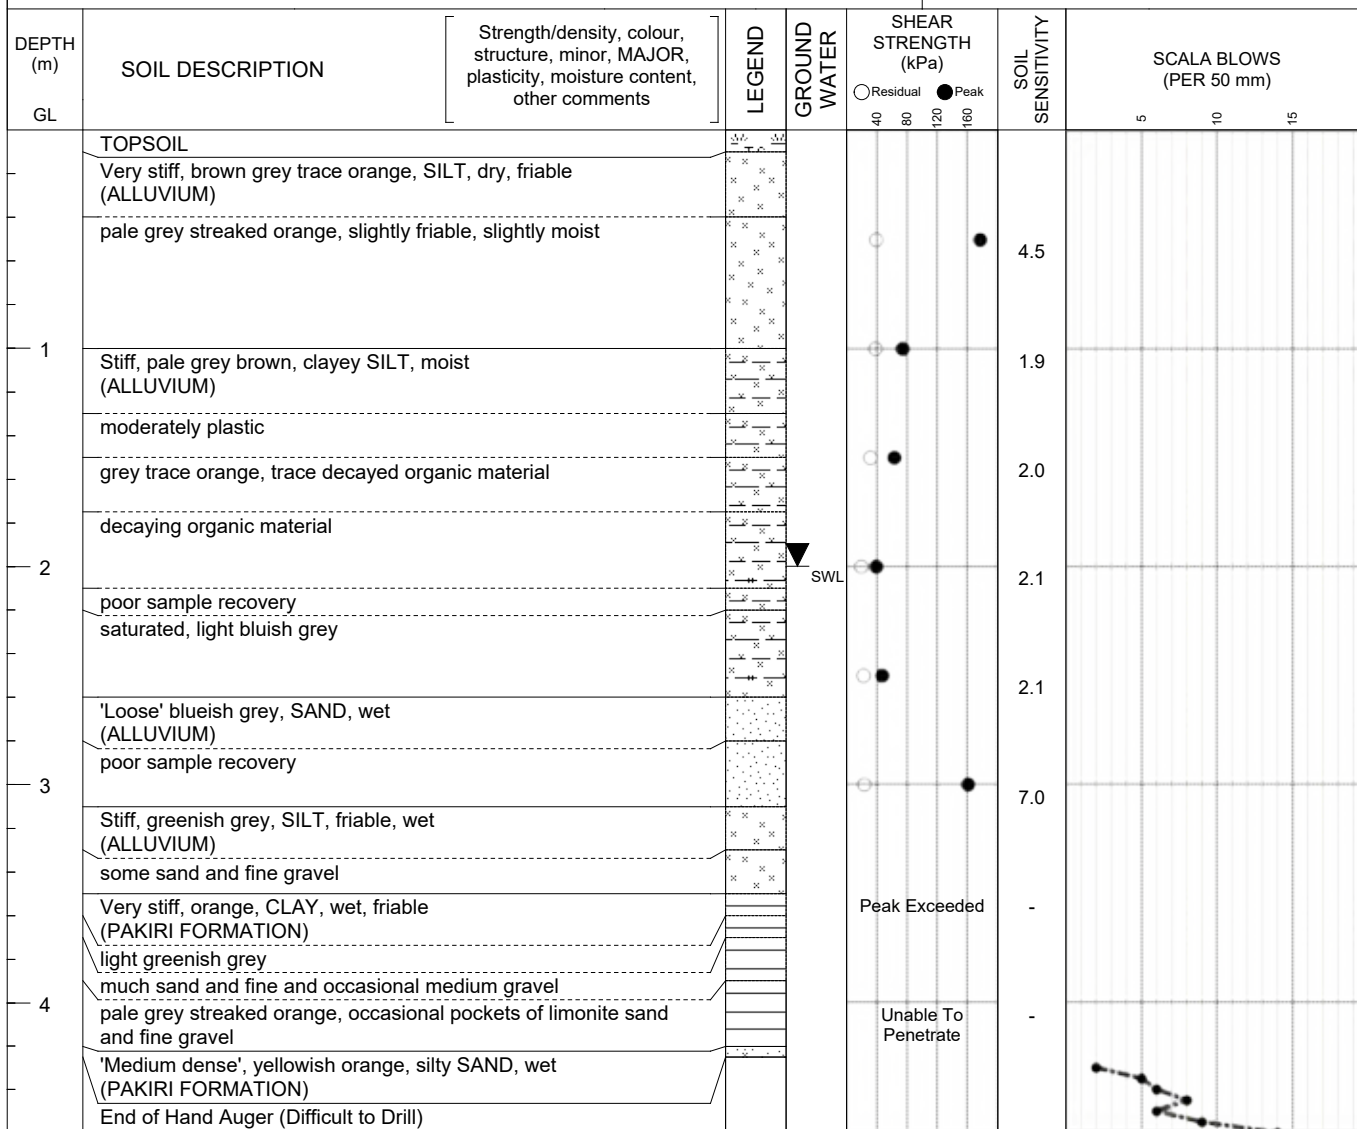
groundwater encountered at 2.0m bgl
Scala bouncing at 4.6m bgl

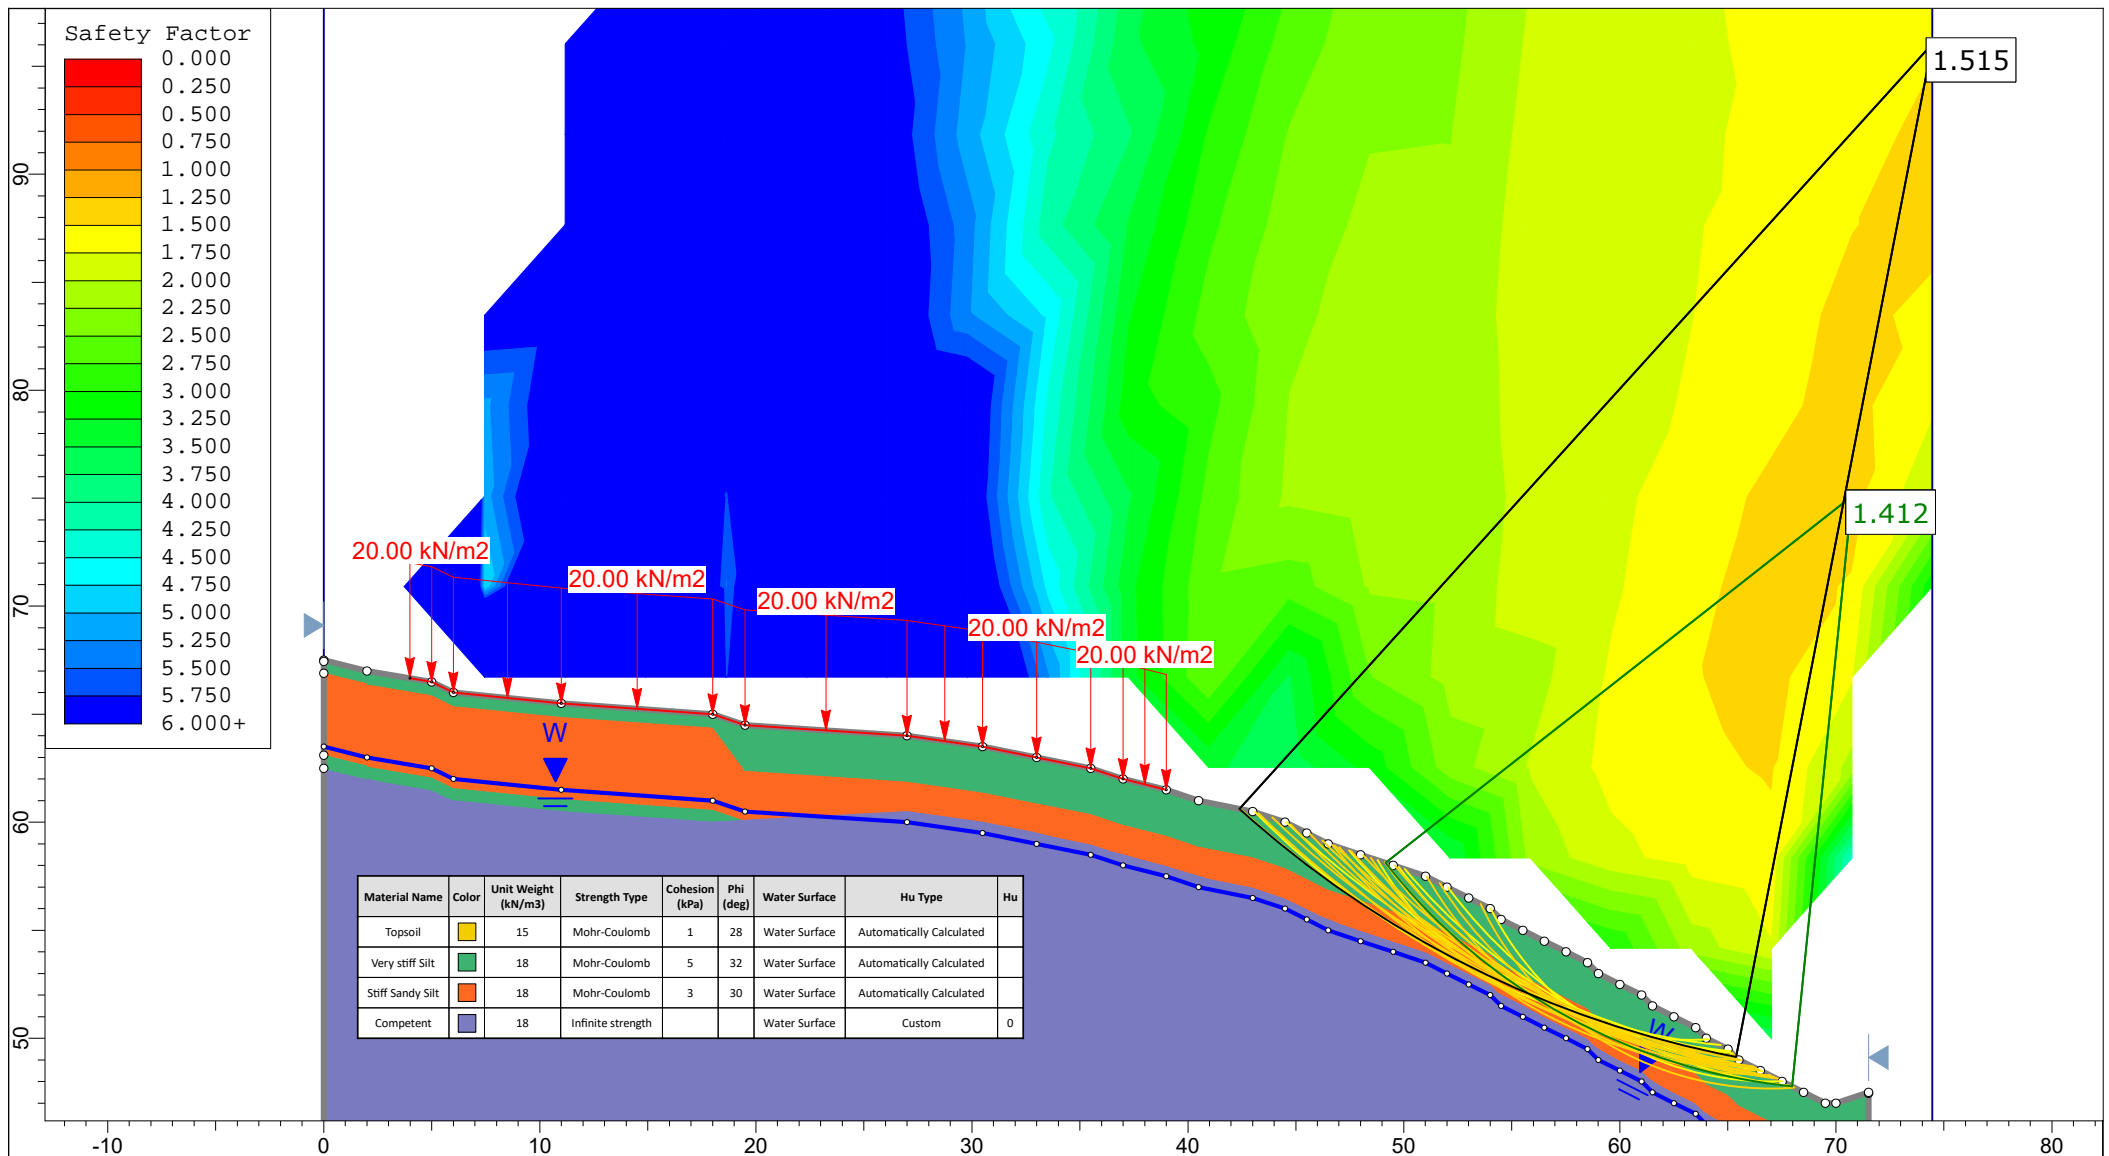
Project			Cowan Bay Farm - Lot 2 - Eastern Gully			
Analysis Description			Slope Stability - Proposed			
Drawn By		DM	Scale	1:350	Company	EDC
Date		March 2017			File Name	232932211.sli

The results indicate that the risk of global failure of the eastern gully slope is possible. The lowest calculated Factor of Safety is below the required in all three models (1.4 for normal conditions and 1.2 for transient conditions). The models indicate that the required Factor of Safety can be achieved if the building platform is setback above the 63m contour (based on the Parallax Surveyors and Planners topographic survey).

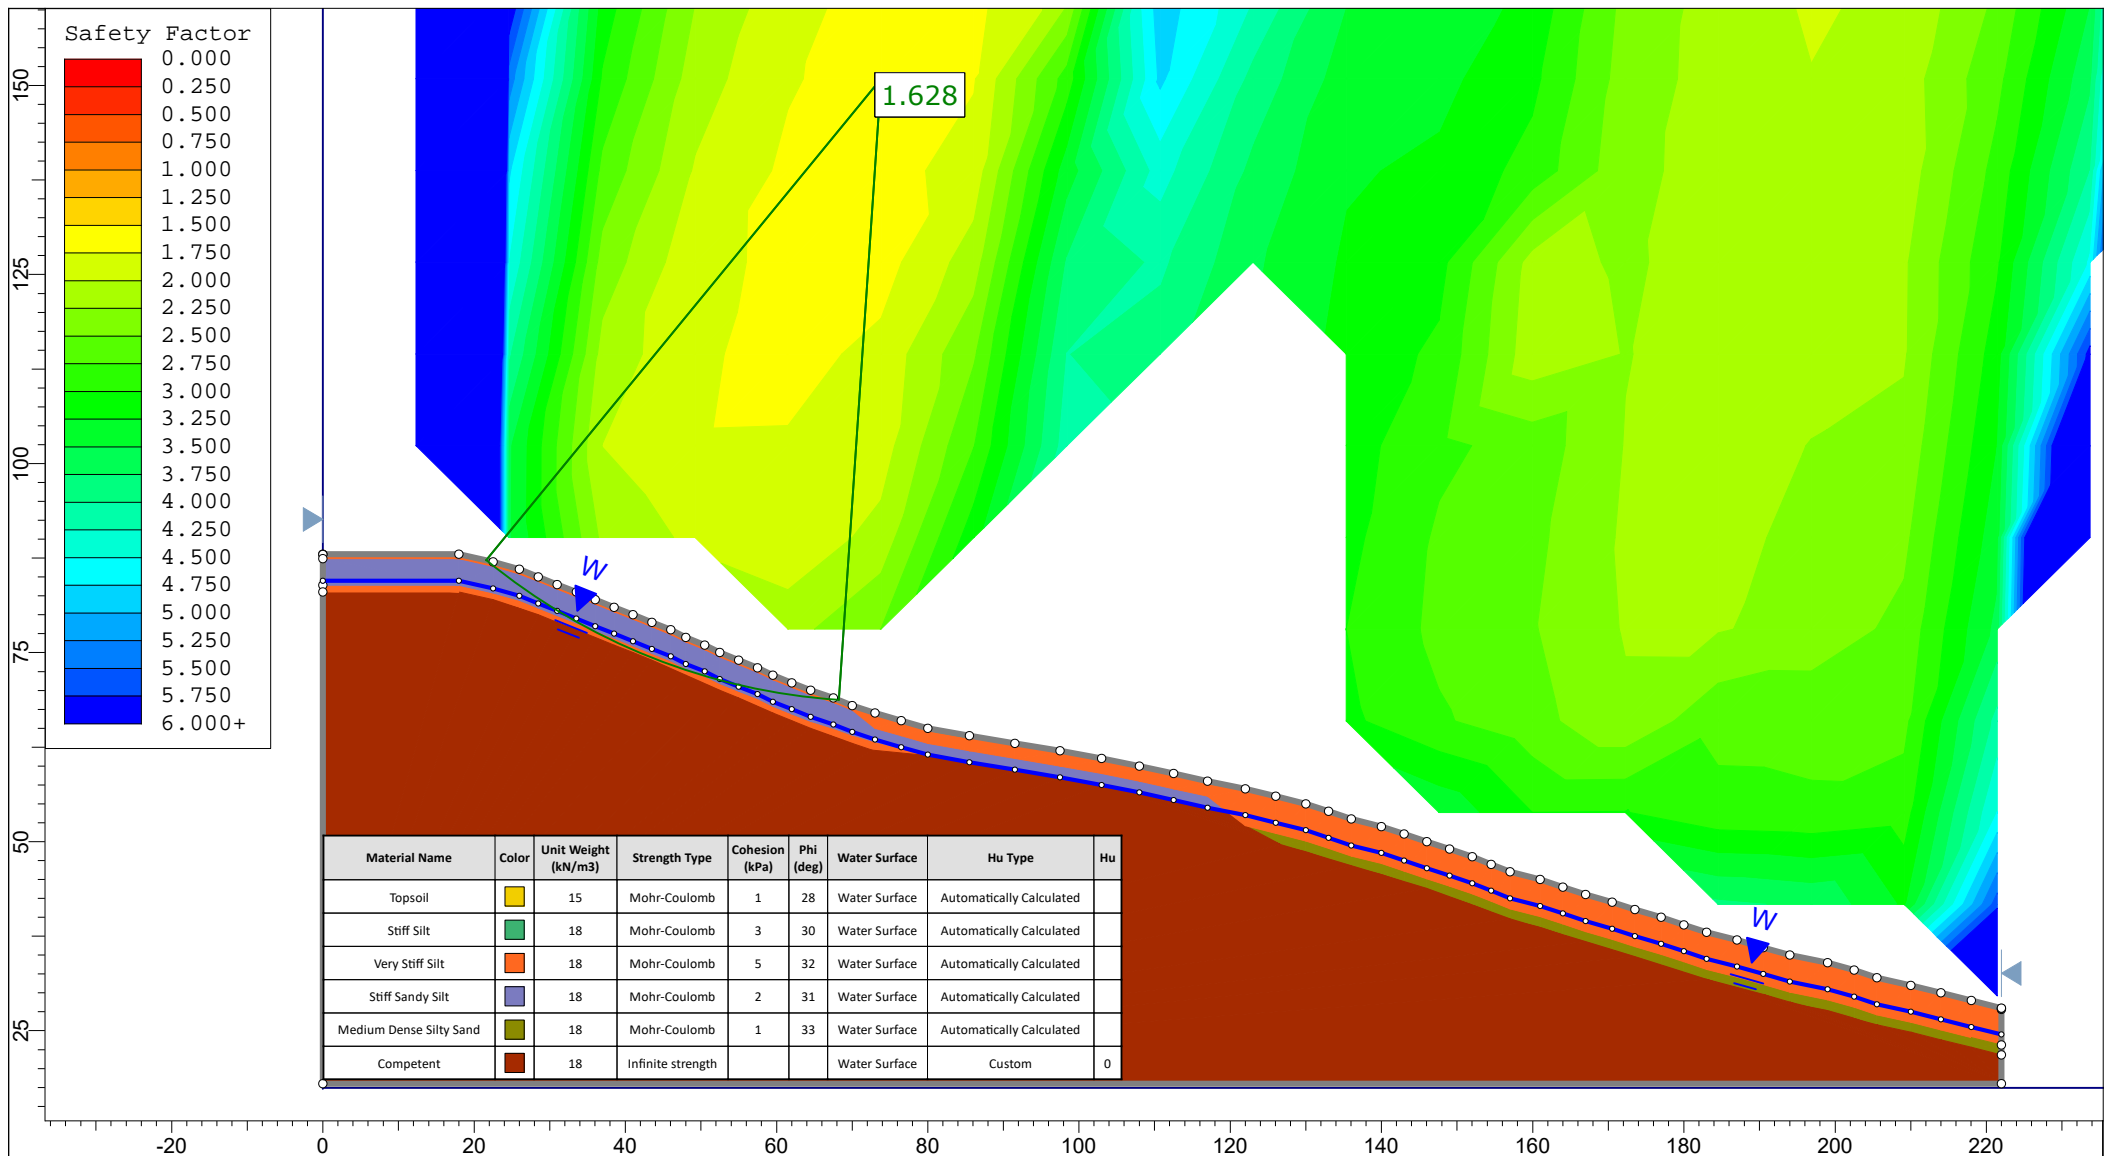
Project			Cowan Bay Farm - Lot 2	
	Analysis Description			Slope Stability Analysis - Existing	
	Drawn By	DM	Scale	1:1000	Company
	Date	March 2017	File Name	2017-03-22-Cowan Bay Farm - Lot 2 - GEO-Slope stability existing.slim

The results indicate that the risk of a global failure of the north eastern slope is unlikely. The north-eastern models indicate a Factor of Safety of 1.6 under normal conditions and 1.3 under transient conditions. The worst case slip circle was above the building platform in all the models.

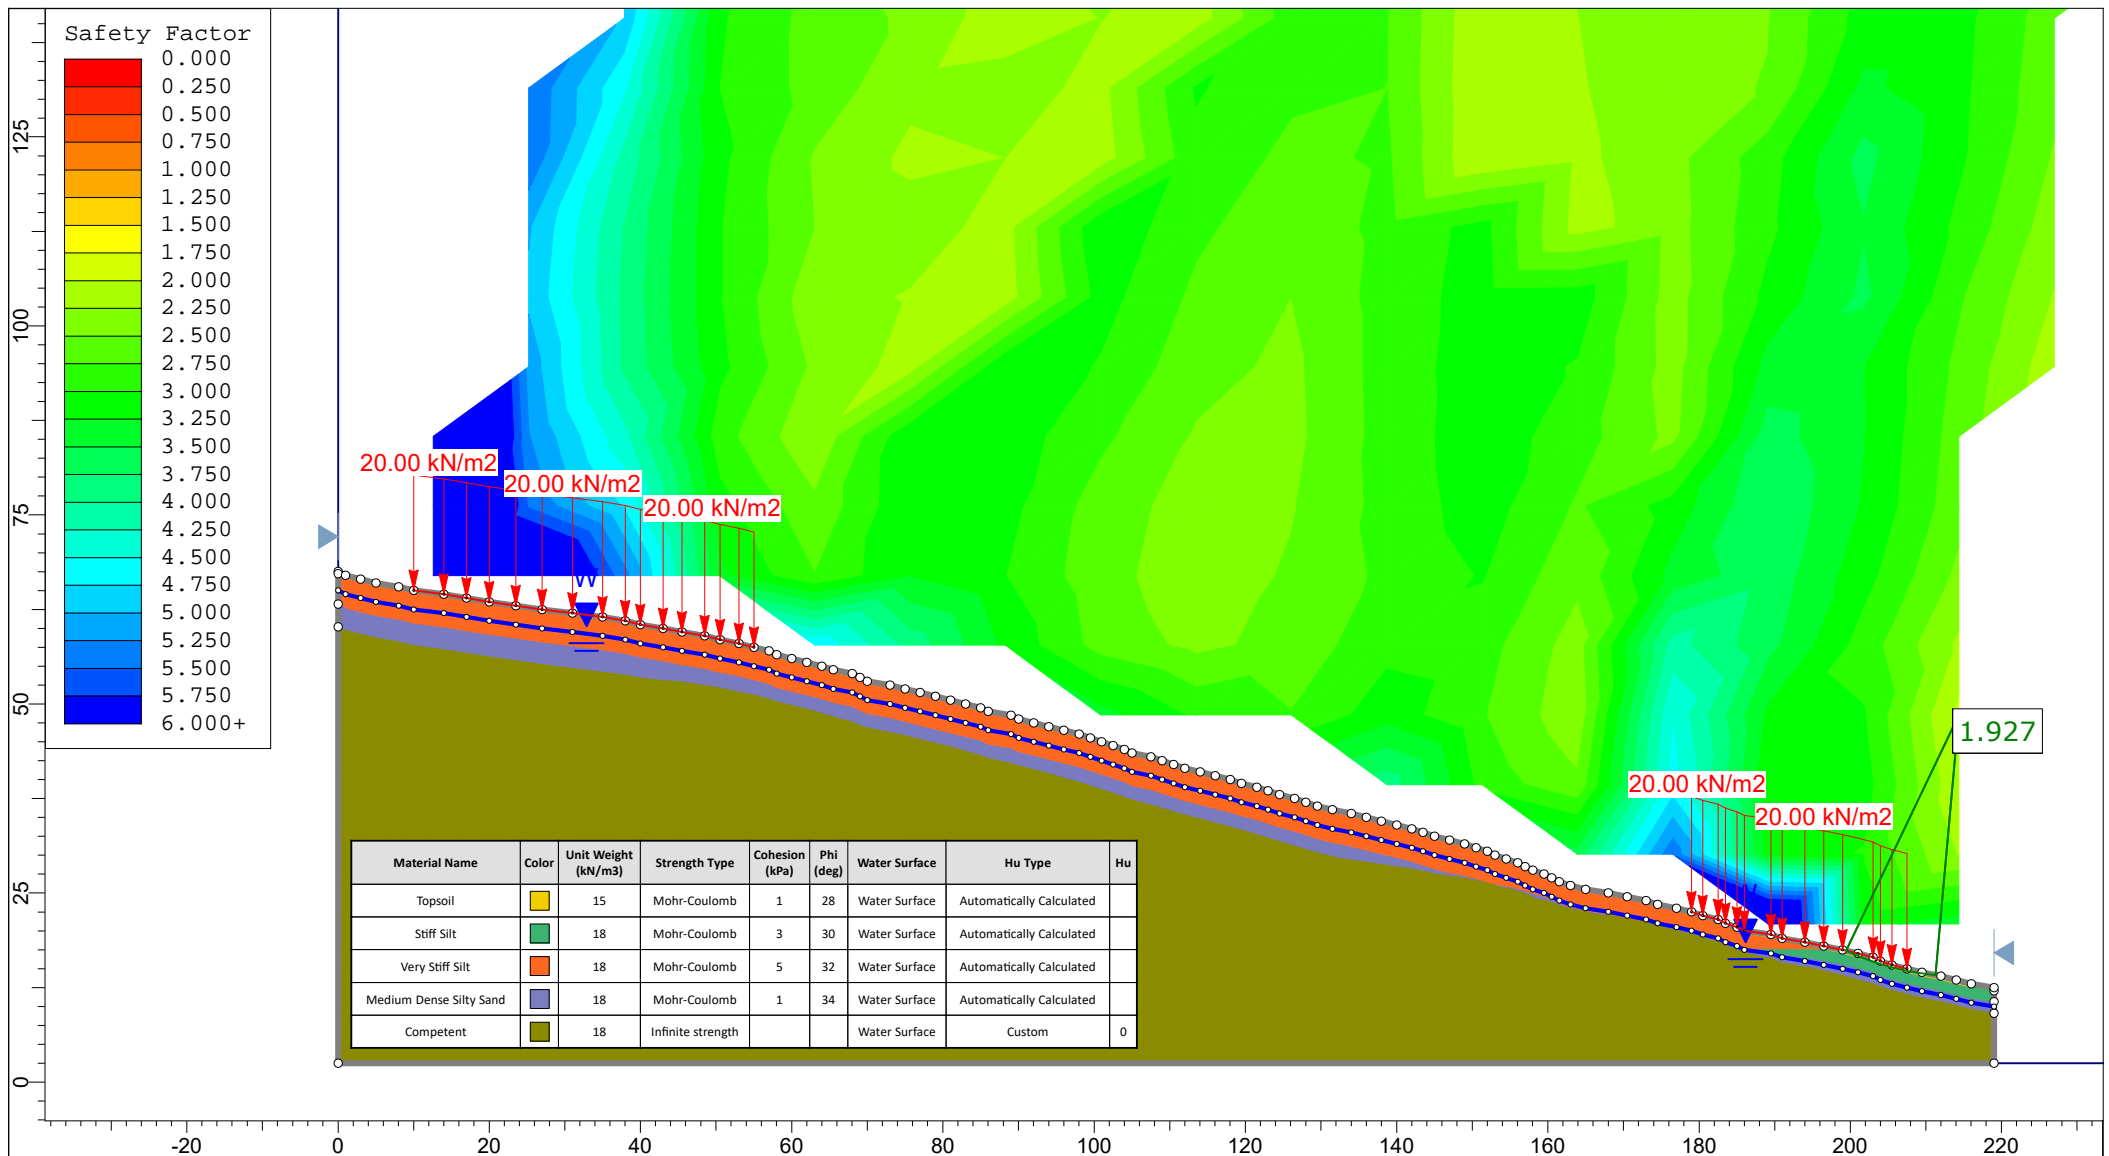
Project			Cowan Bay Farm - Lot 3		
Analysis Description			Slope Stability - Proposed		
Drawn By	DM	Scale	1:1000	Company	EDC
Date	April 2017	File Name	2017-03-29-Cowan Bay Farm - Lot 4 & Possible Lot 3 - GEO - Slope stability Proposed.slm

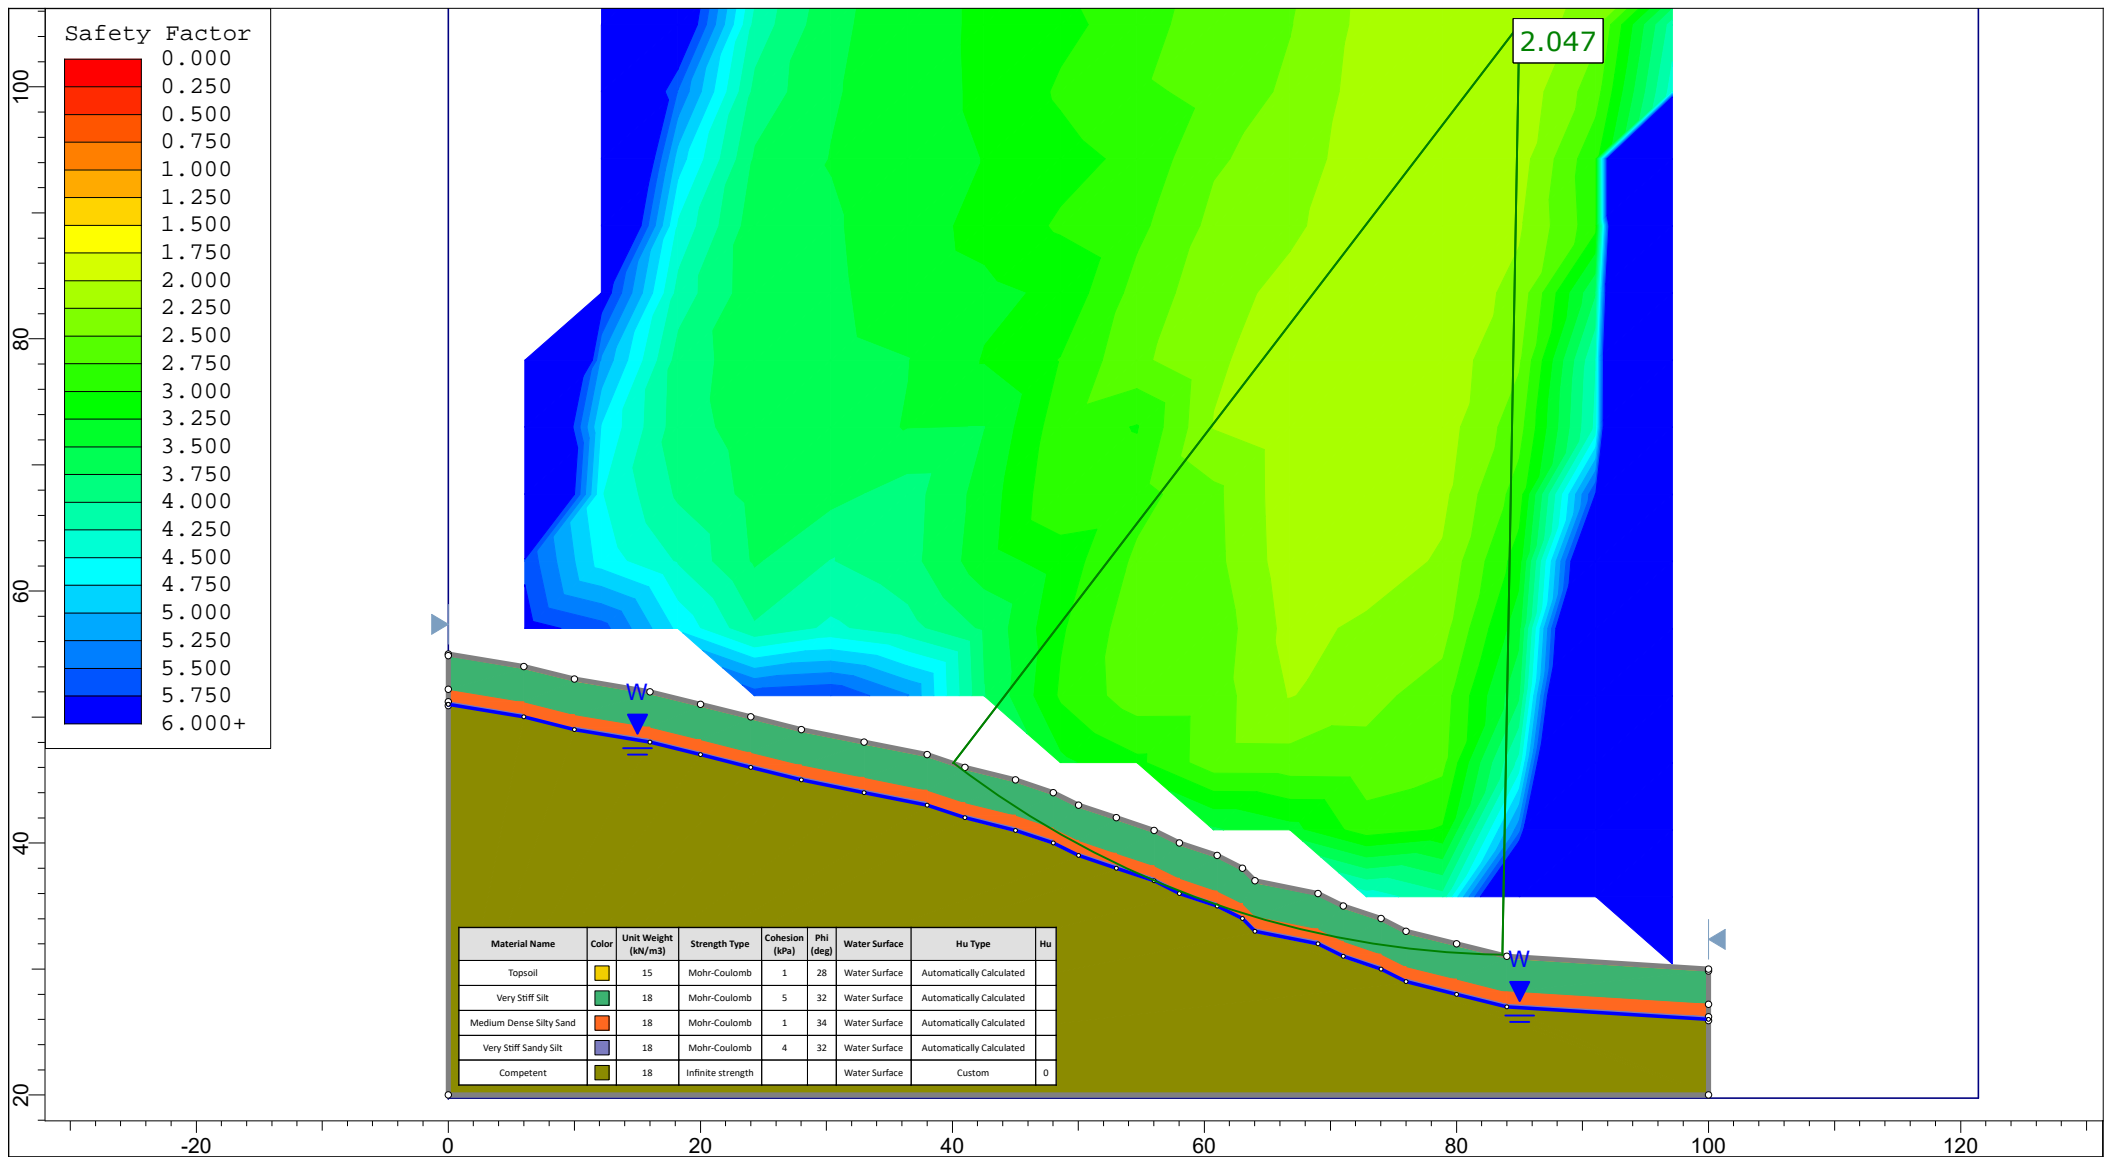
SLIDEINTERPRET 7.009	Project				
	Cowan Bay Farm - Lot 4: Gully Slope				
	Analysis Description				
	Slope Stability - Existing				
	Drawn By		DM	Scale	1:600
					EDC
Date		April 2017			File Name
					2017-04-27_Cowan Bay Farm_Lot 4_Gully Slope_Existing.slim

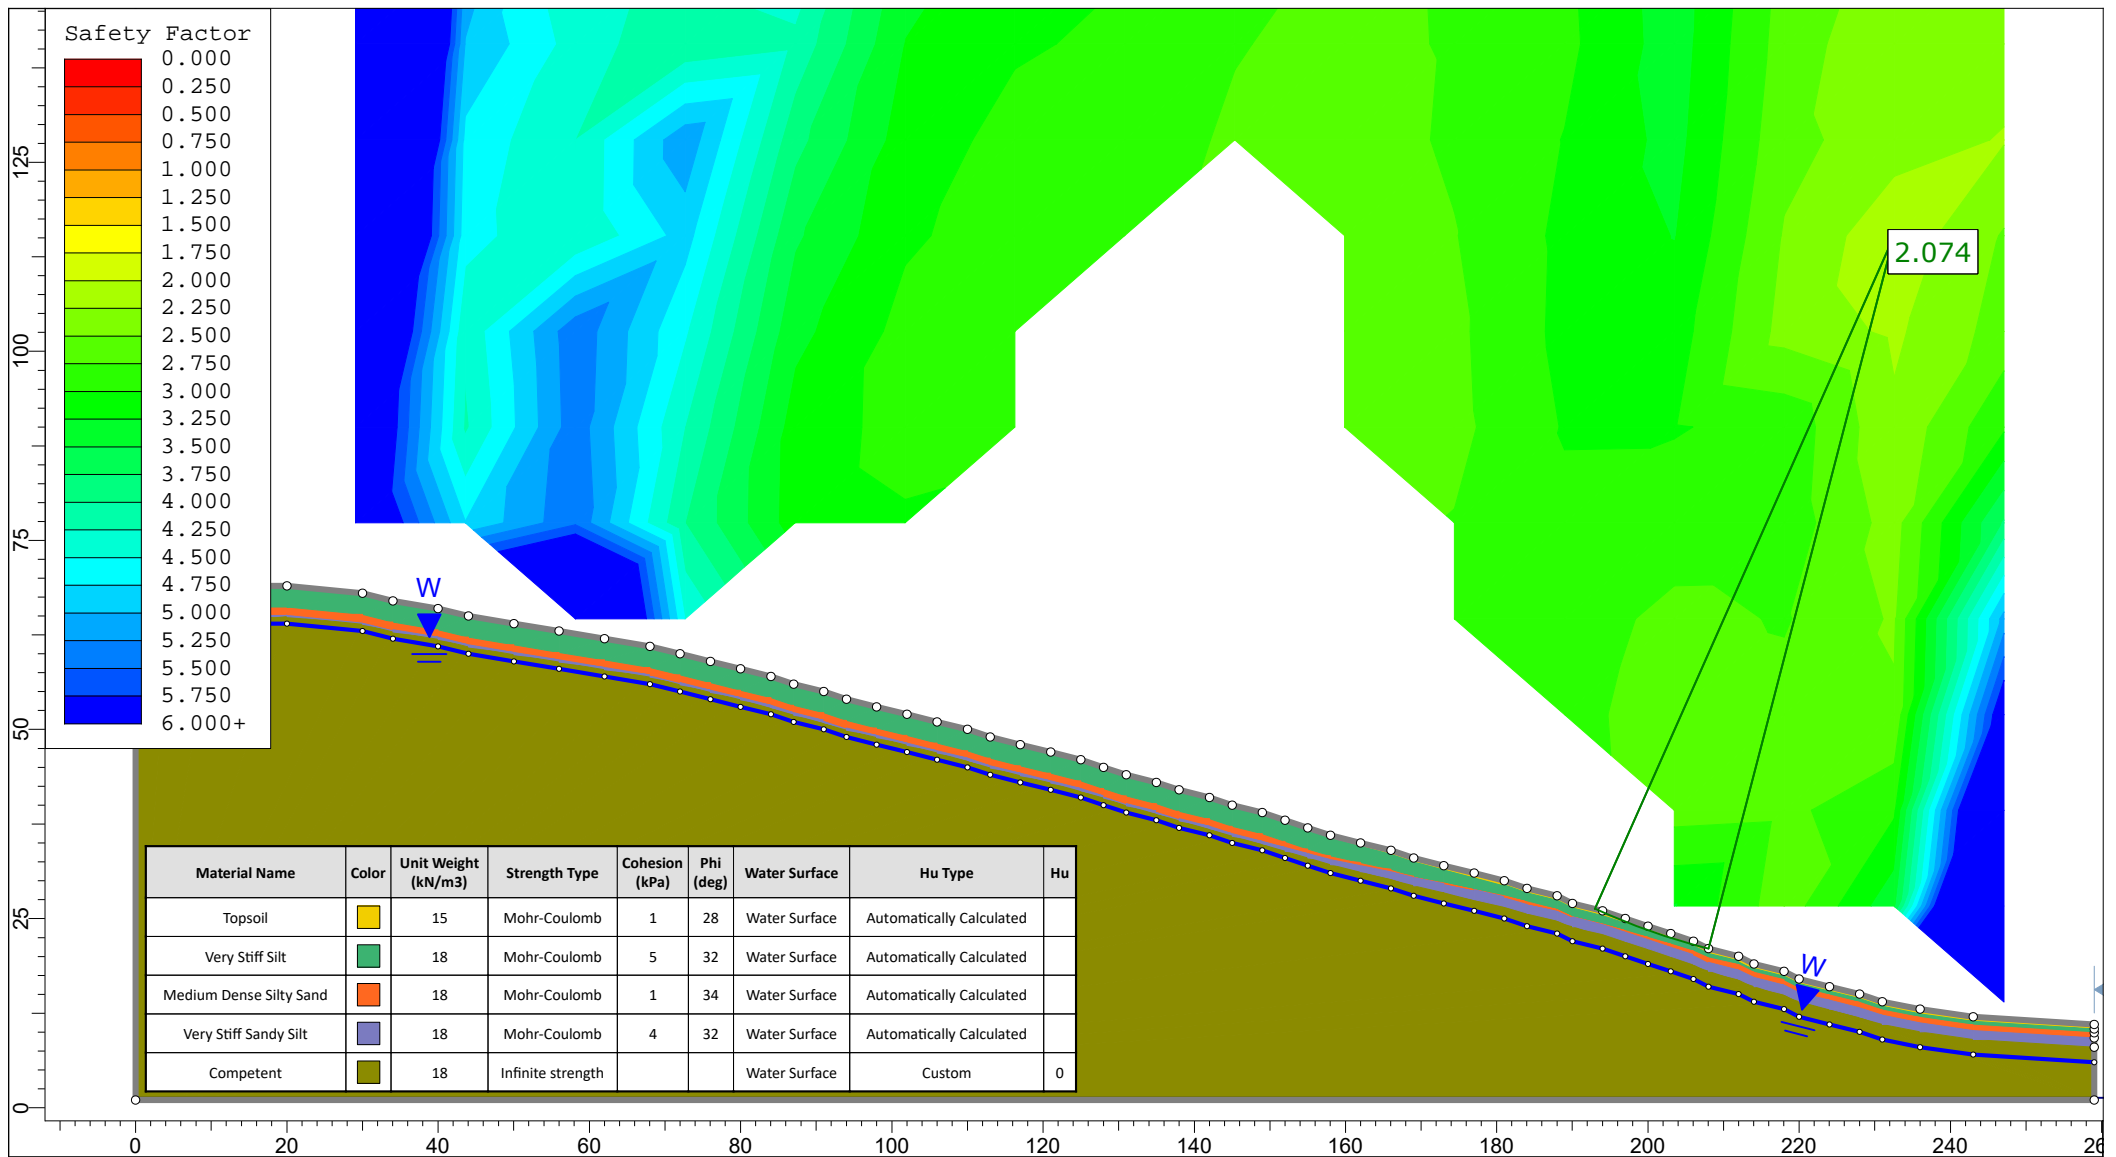
SLIDEINTERPRET 7.009	Project				
	Cowan Bay Farm - Lot 4: Northern Slope				
	Analysis Description				
	Slope Stability - Existing				
	Drawn By		DM	Scale	1:1000
					EDC
Date		April 2017			File Name
					2017-04-27_Cowan Bay Farm - Lot 4_Existing.slim

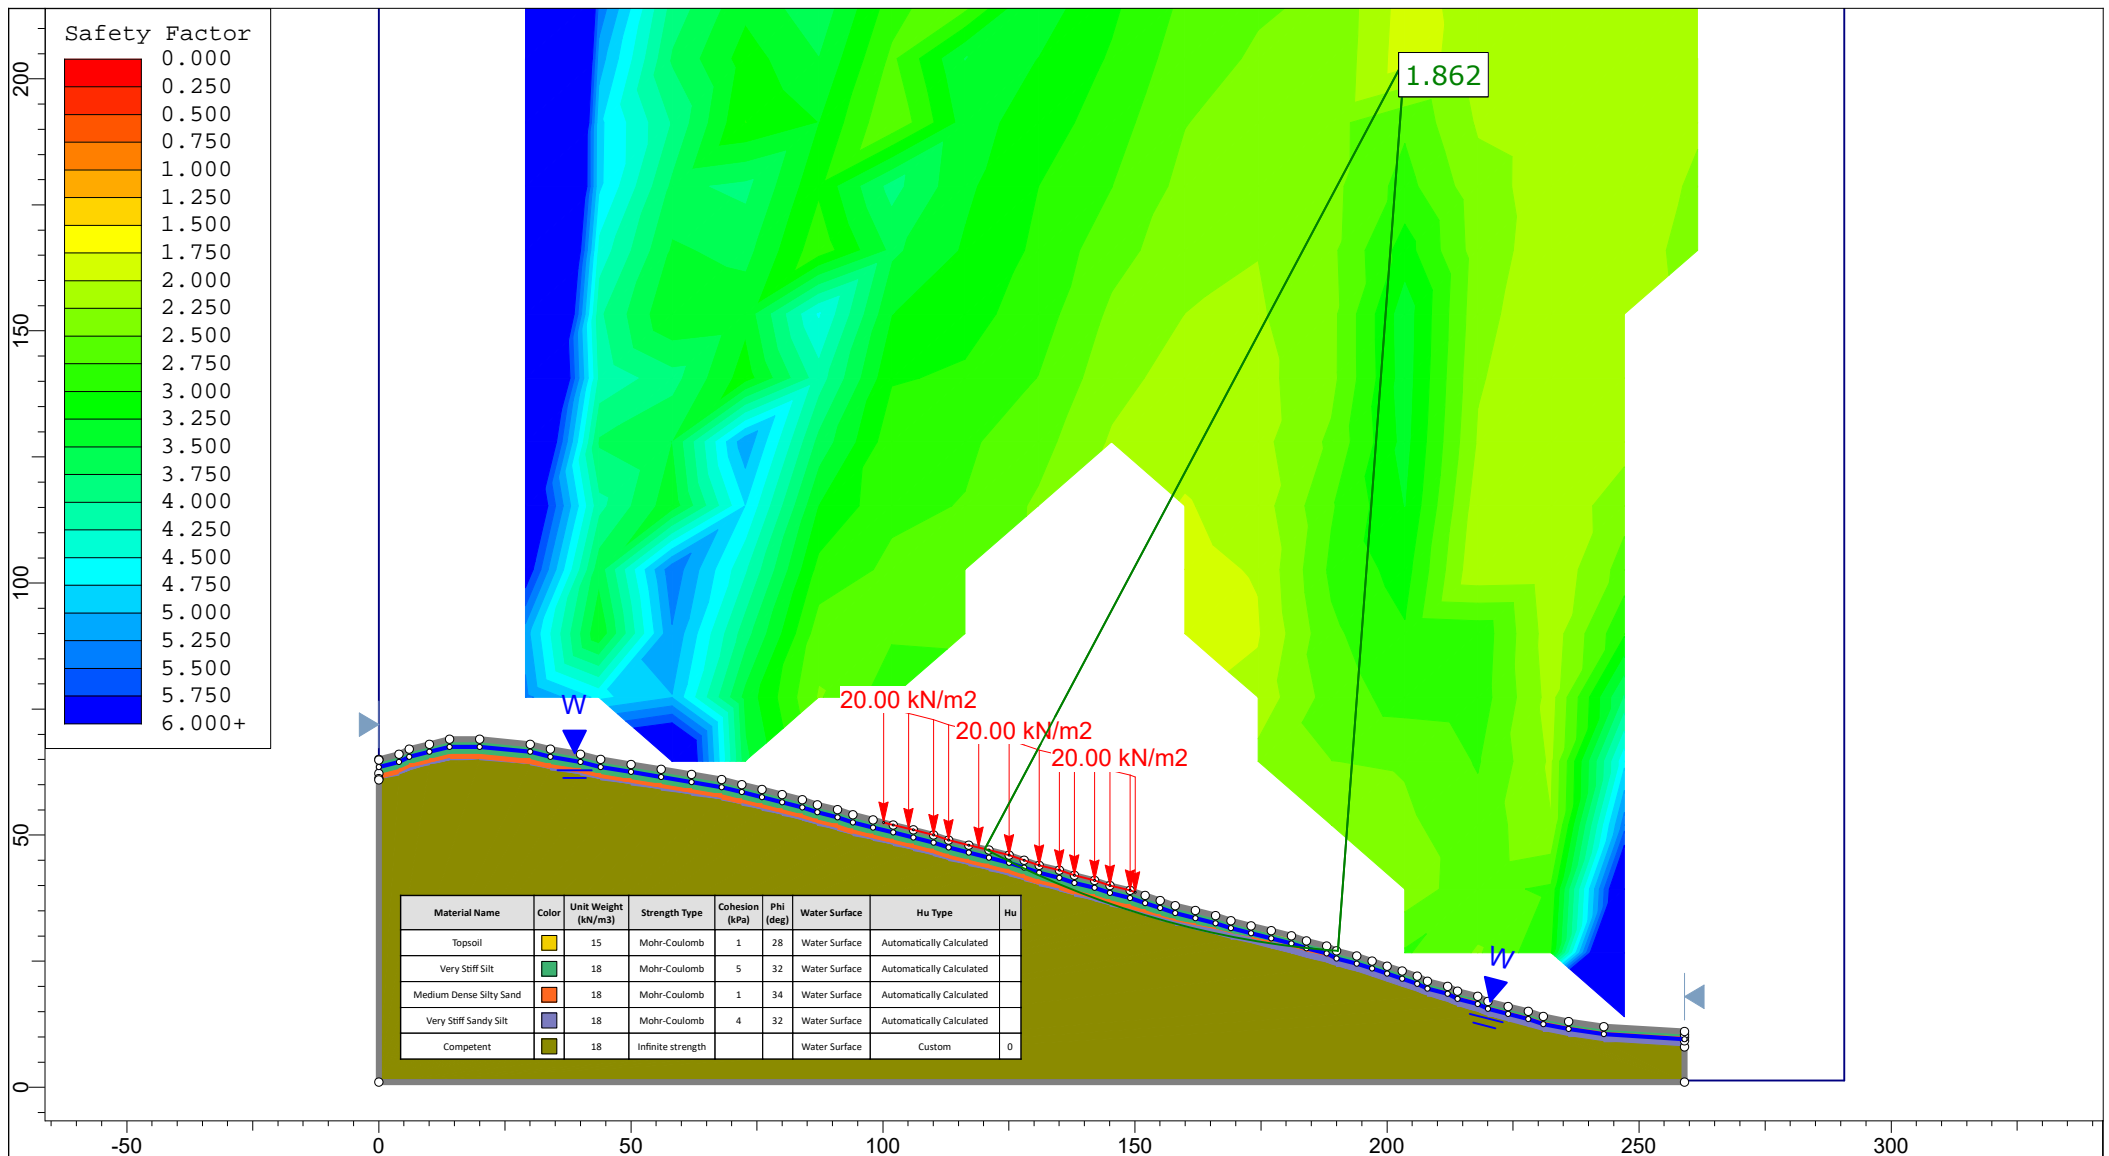
Project			Cowan Bay Farm - Lot 4: Northern Slope		
Analysis Description			Slope Stability - High Groundwater		
Drawn By	DM	Scale	1:1500	Company	EDC
Date	April 2017	File Name	2017-04-27_Cowan Bay Farm - Lot 4_High Groundwater.slim

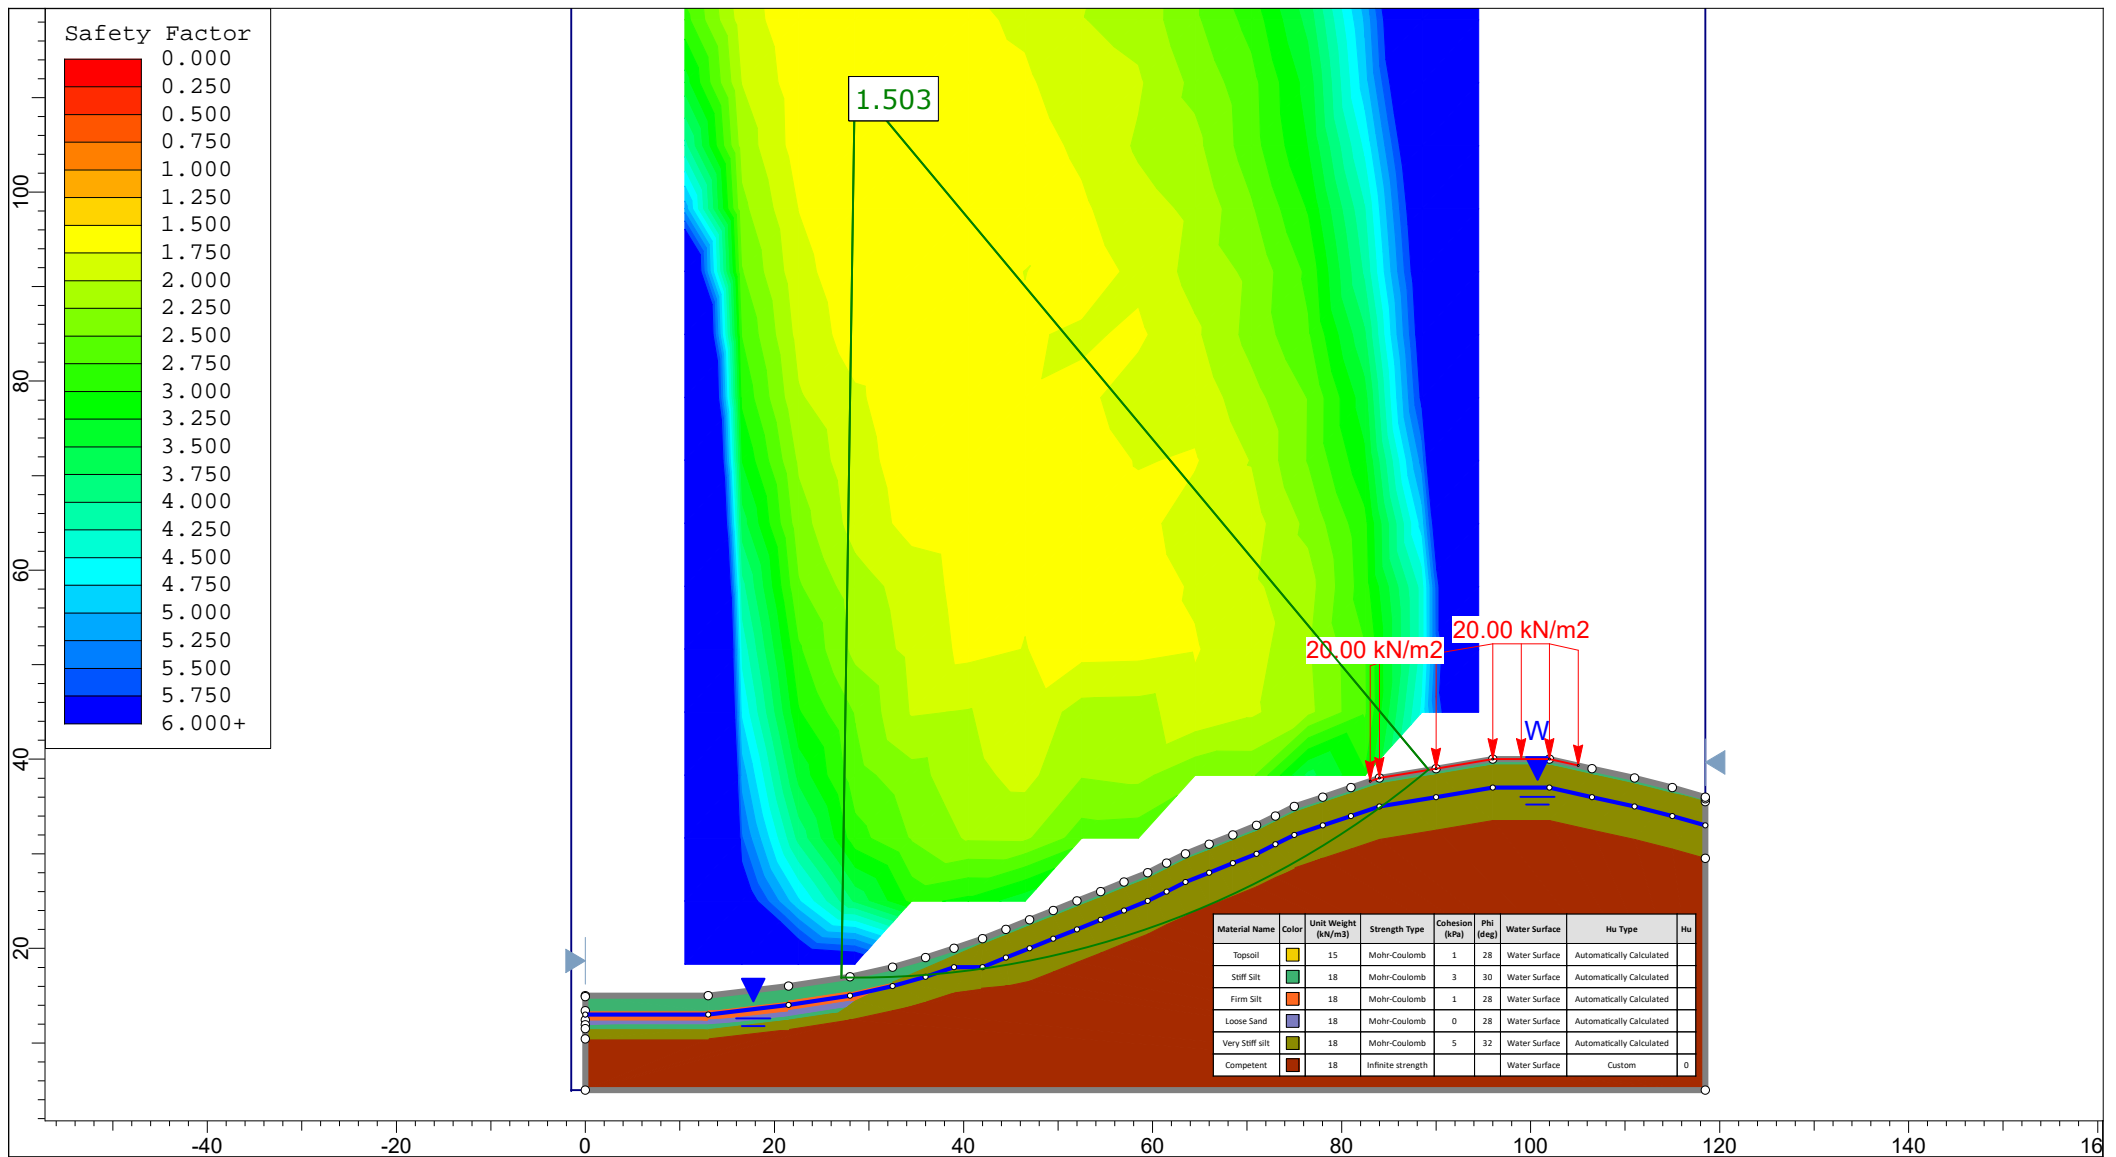
SLIDEINTERPRET 7.009	Project				
	Cowan Bay Farm - Lot 5				
	Analysis Description				
	Slope Stability - Proposed				
	Drawn By		DM	Scale	1:800
					EDC
Date		March 2017			File Name
					2017-03-21_Cowan Bay Farm Lot 5-GEO-Slope Stability Proposed.slim
